*Innovative Infrared Nondestructive Evaluation  
Technologies*

# What is IR-UTD?

- Infrared Ultra-Time Domain Thermography (IR-UTD)
- New technology designed to detect subsurface damage (delams) in concrete decks, superstructures, and substructures
- Transient thermography – *time-based* data collection

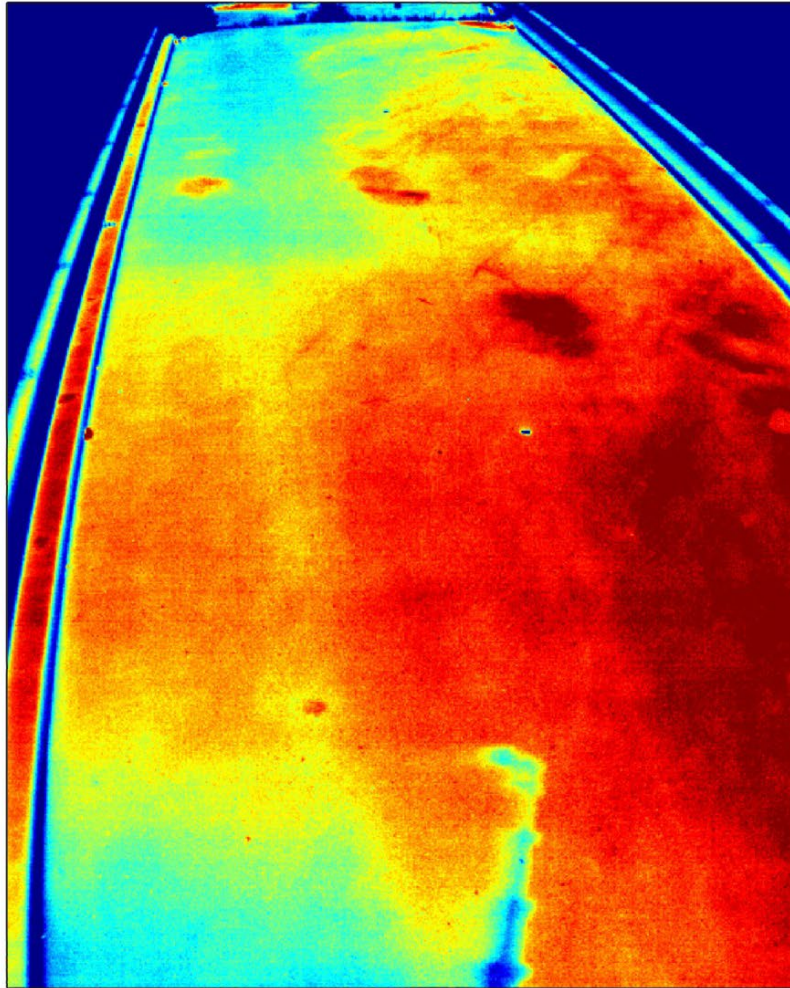
Conventional IR (maximum contrast)

# Comparison Between Conventional IR and IR-UTD Imaging

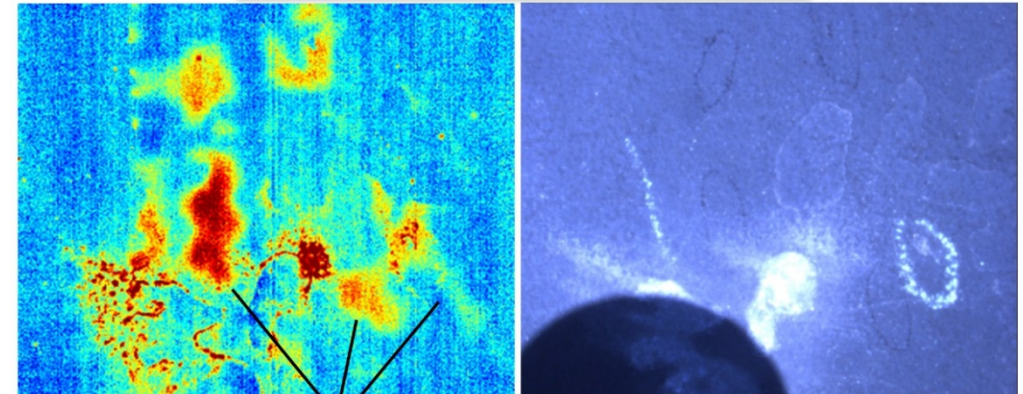
## Defects under metalizing

Defect Indications (multiple; not all indicated)

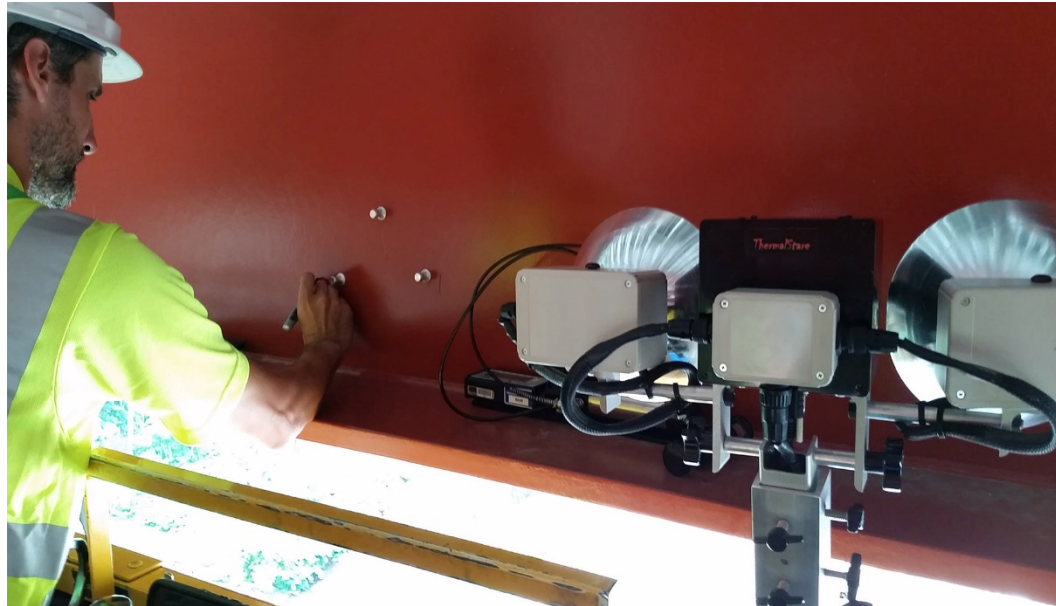
Defect indication

Top flange

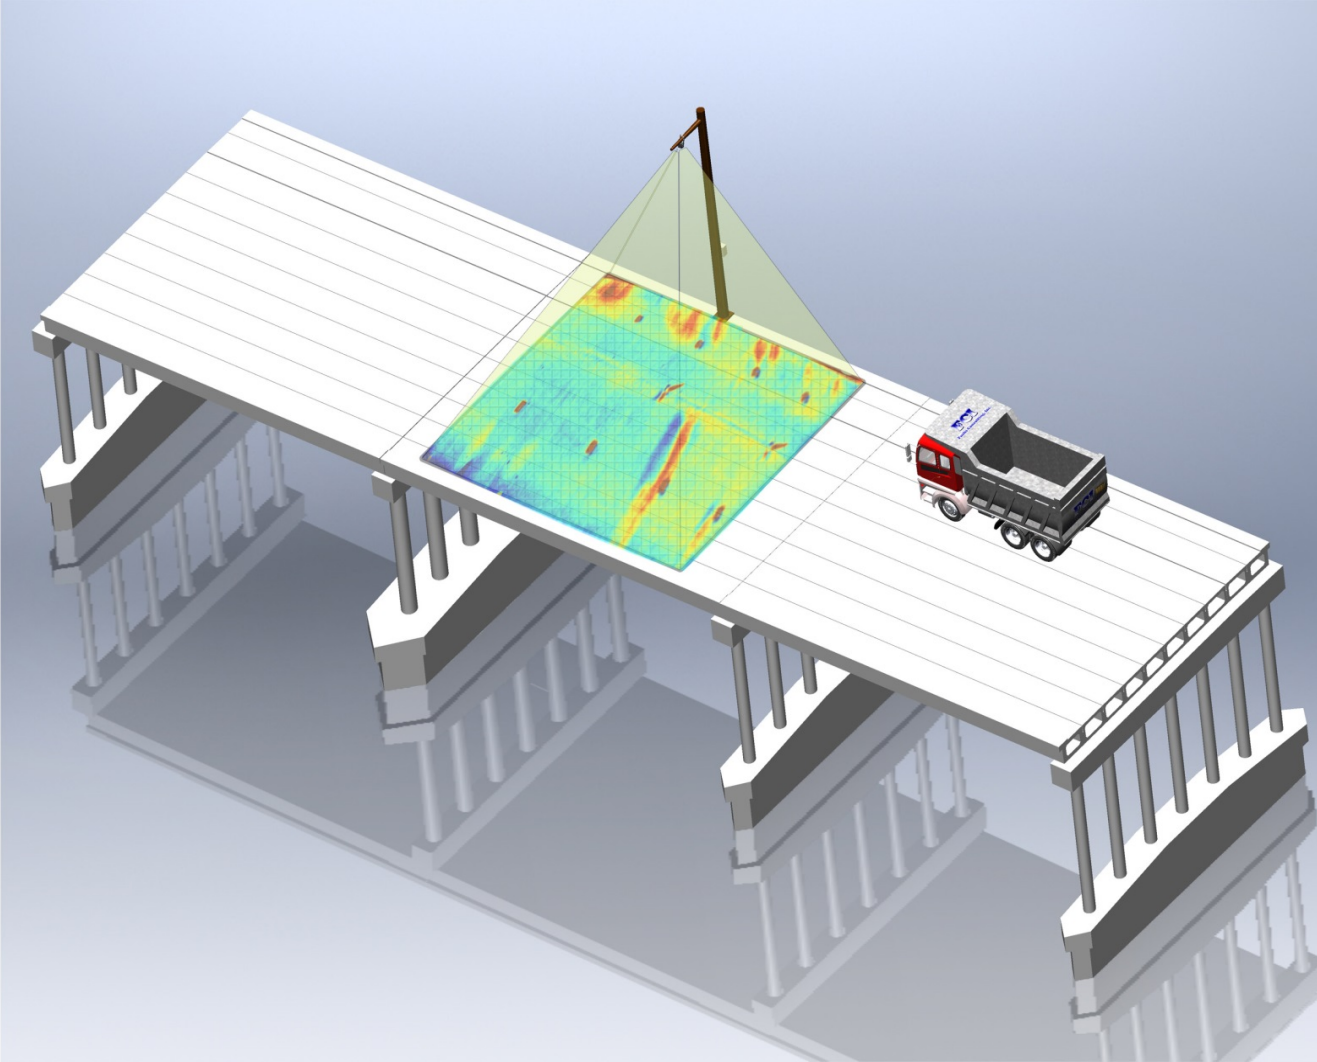
- *Measure large area of deck*
- *Long-term measurements*
- *Collect data with all lanes open to traffic*
- *Multiple installation options*

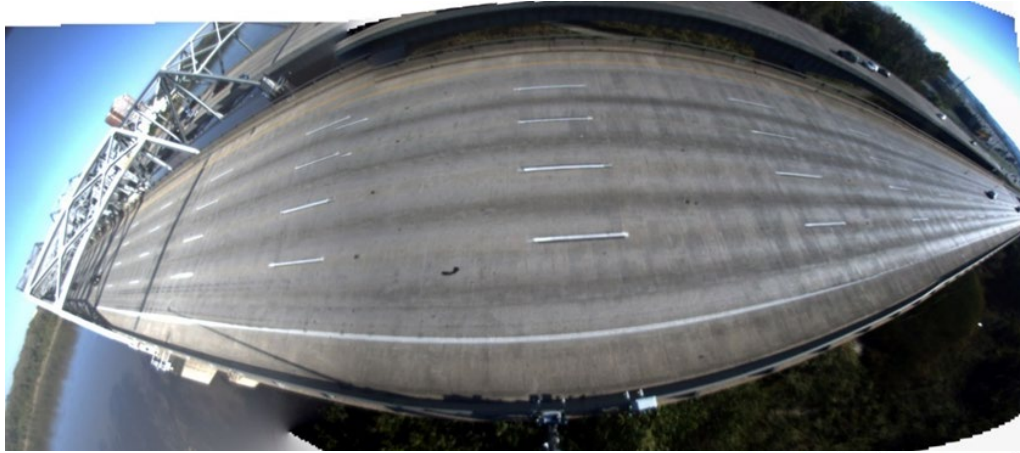
Field of view from mast

- *Collects data with all lanes open to traffic*
  - Vehicles removed from images through advance signal processing

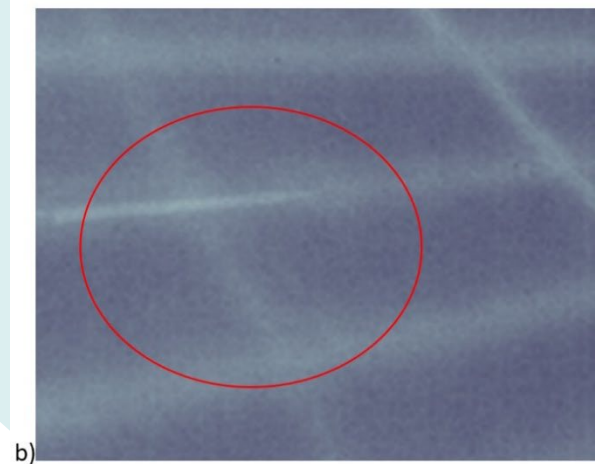
IR-UTD processed to show structure

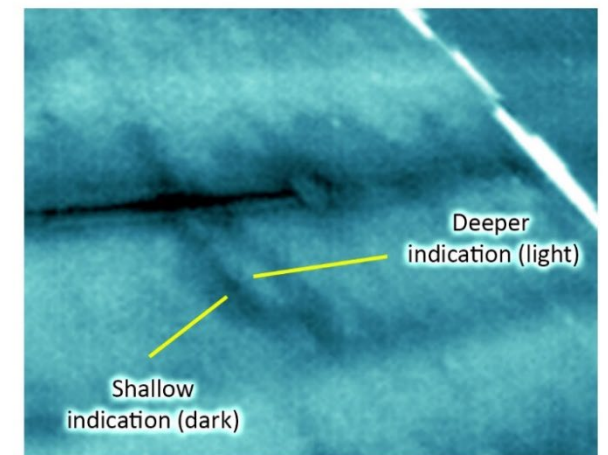
IR-UTD Image with labels

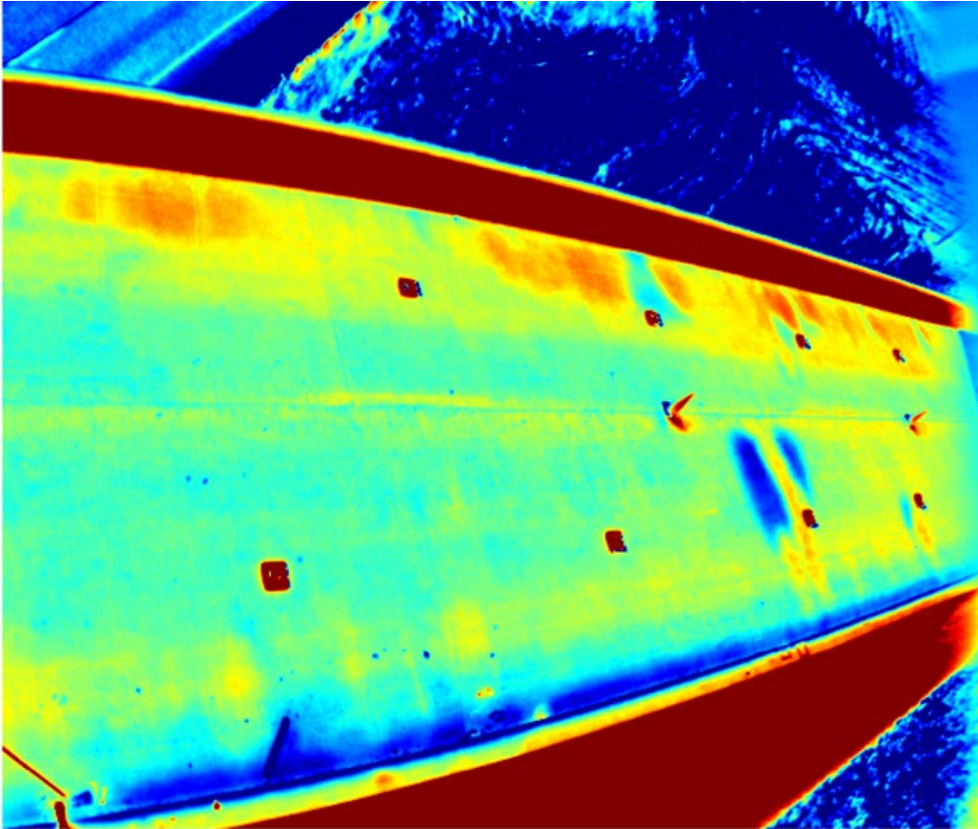
IR-UTD Image

# Bridge Deck - Iowa

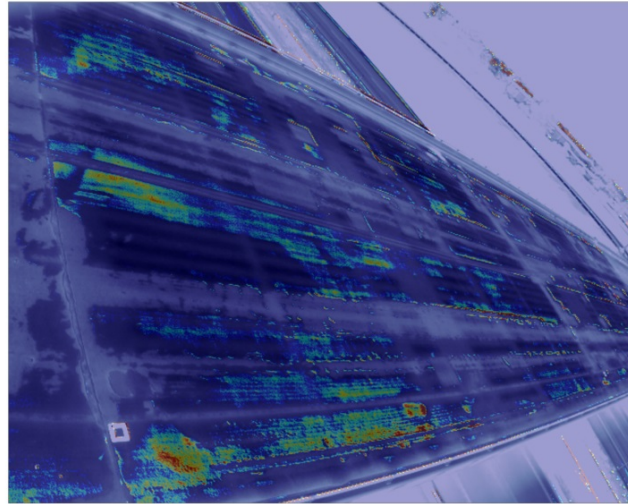
IR-UTD:  
Overlay of defects  
and structure

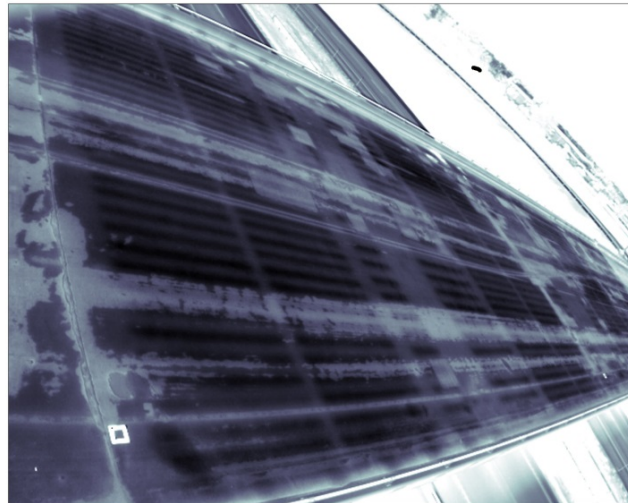
IR-UTD:  
Internal features

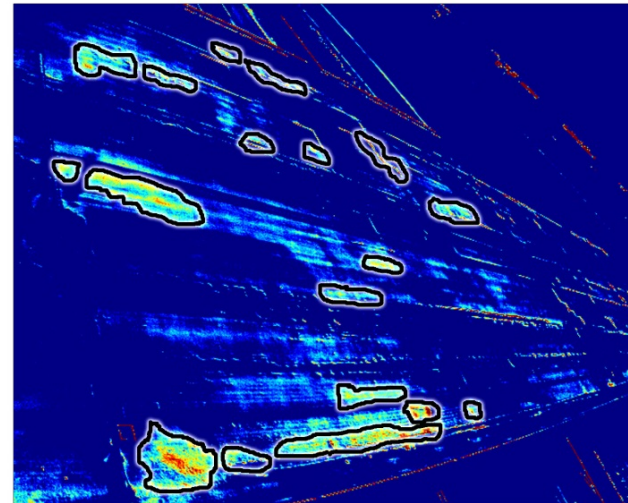
IR-UTD:  
Delaminations

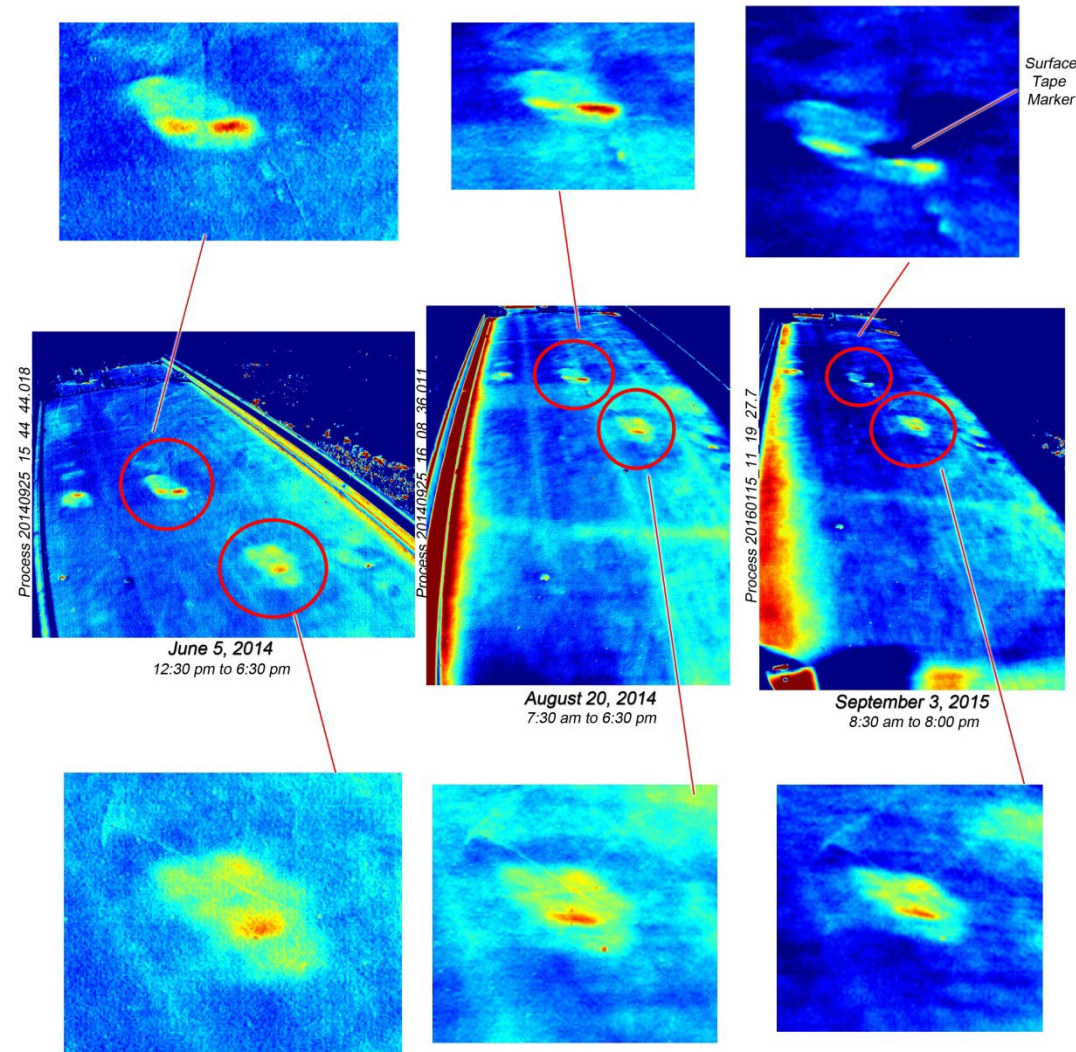
- *Repeatable images from*
  - June 2014
  - August 2014
  - September 2015
- *Show same defects with same characteristics*
  - Different positions of mast
  - Different weather conditions
  - Different data collection times

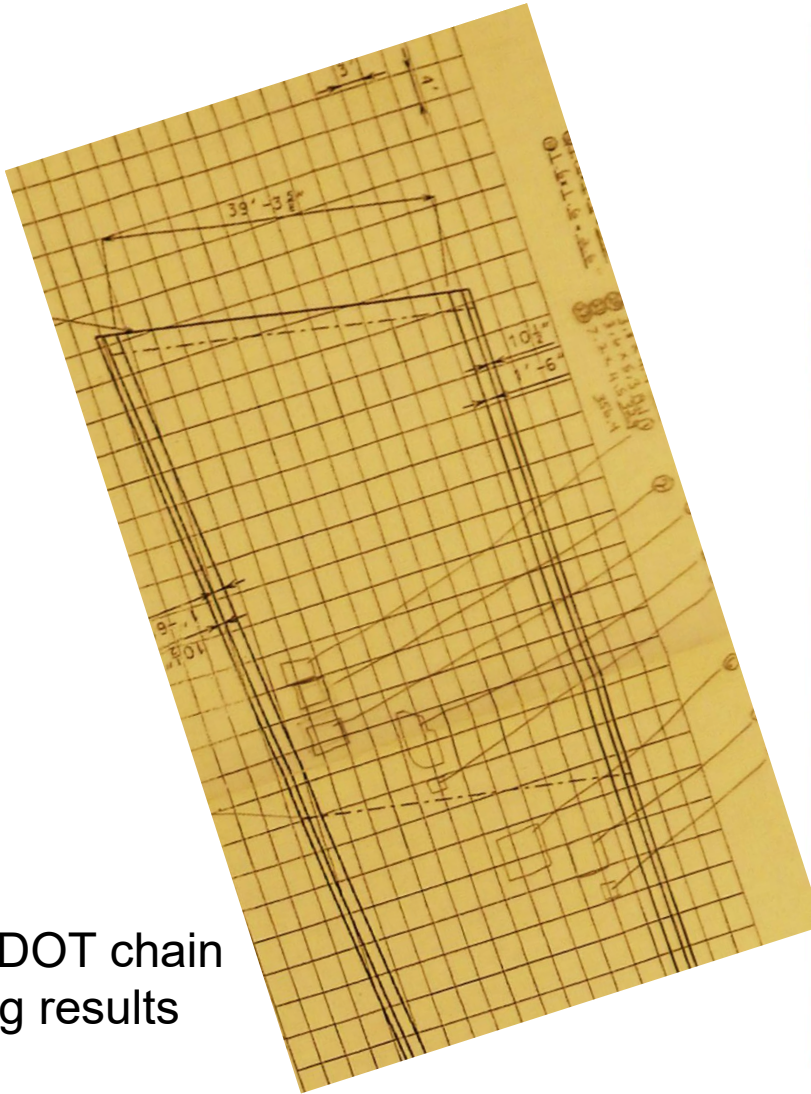
MoDOT chain  
drag results

# IR-UTD: Chain Drag Comparison

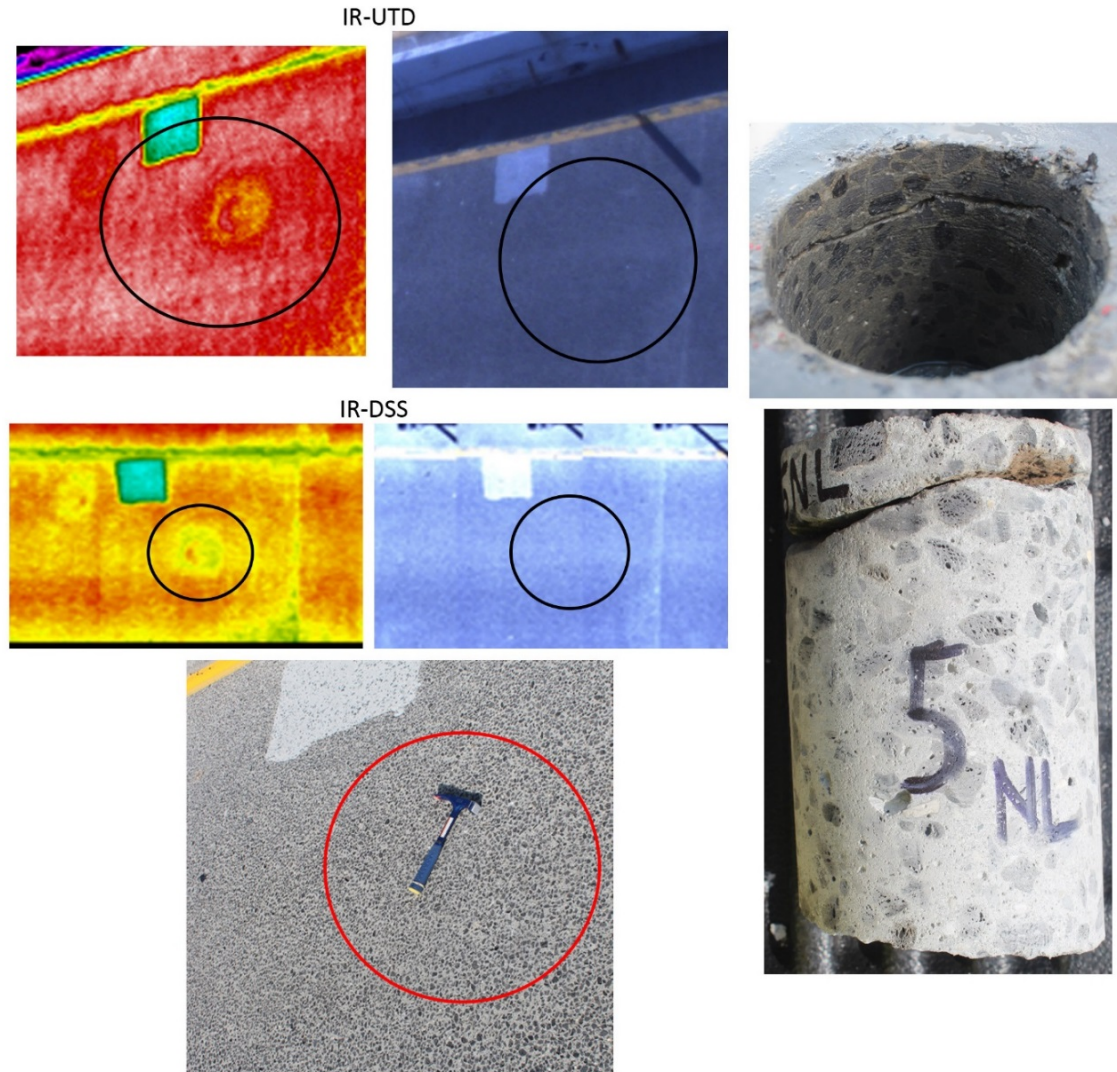
- *Frances Scott Key*
  - 19/19 correct
  - 19 pre-selected cores
  - Intact and defect cores
- *Chesapeake Bay Bridge*
  - 11/12 correct
  - 12 pre-selected cores
  - Intact and defect cores

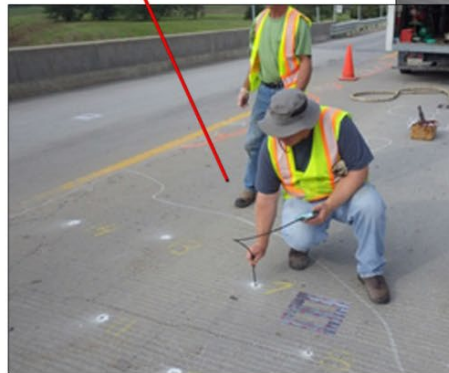
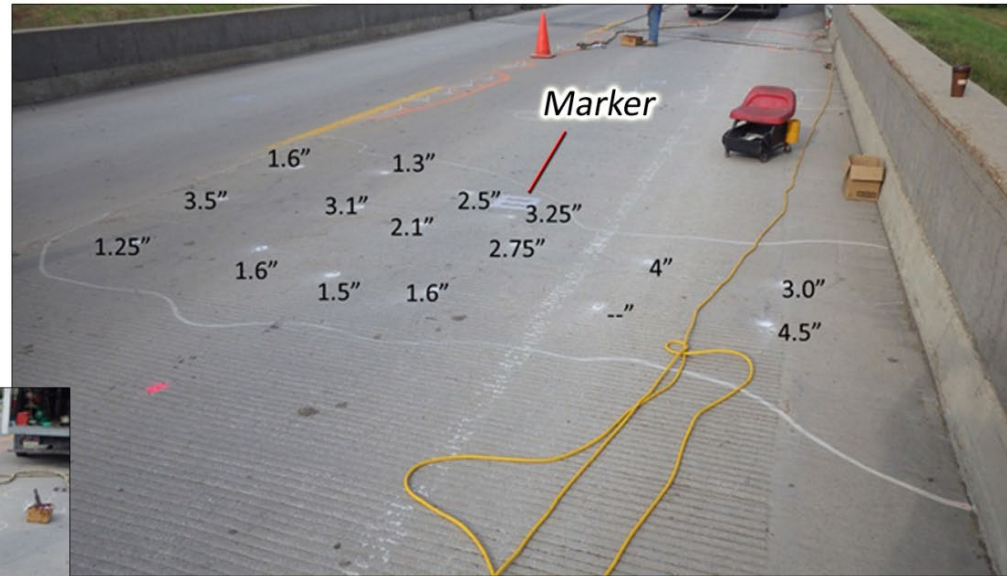
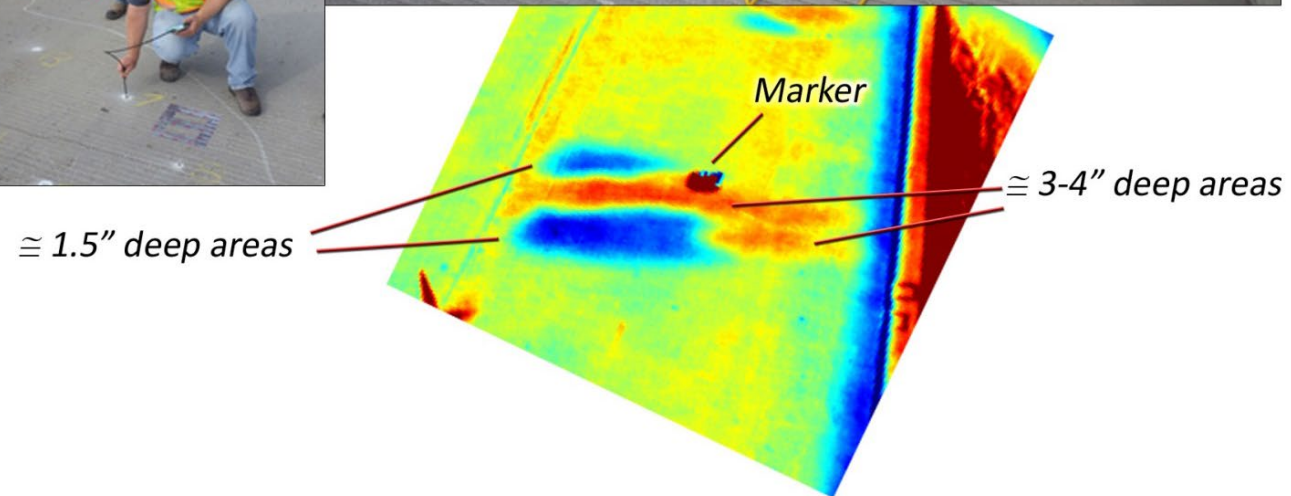
Depth measurement  
with borescope

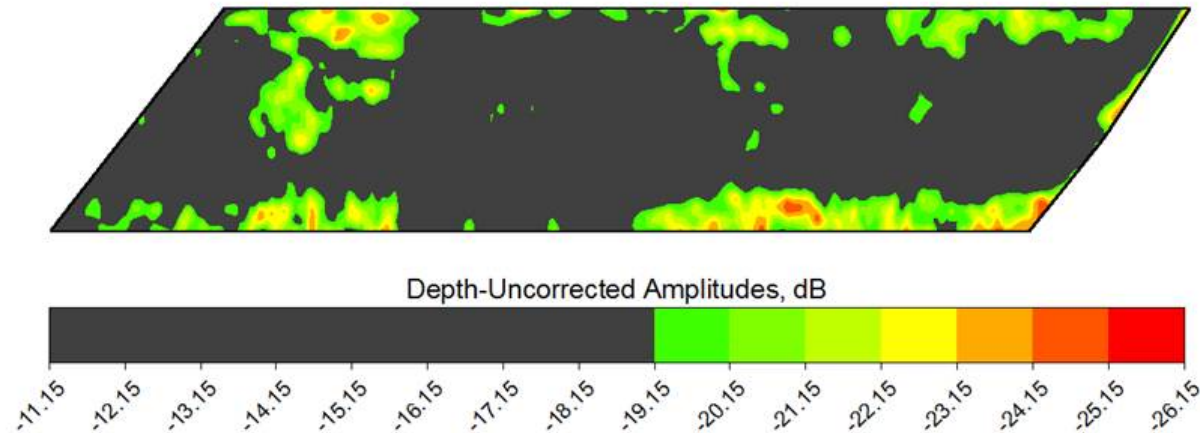
22% damage

- 8 dB
